SPECIAL COMMITTEE ON RIVERFRONT ACTIVITIES AND BASEBALL

2020-2022 NEDD DEFERRED MAINTENANCE PLAN

A. Assessment Overview

Facility Condition Assessment Study Overview

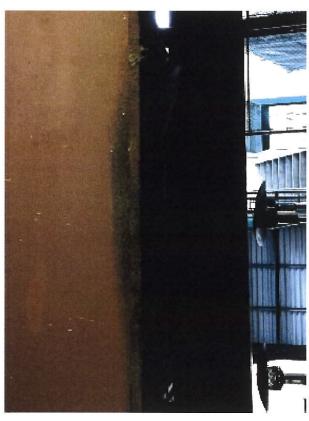
Water Infiltration

Exposure: Active leaks increases threats to underlying structure and interior finishes.

Impact: Unsightly appearance of damaged interior finishes and rusted structural members.

Crack in slab

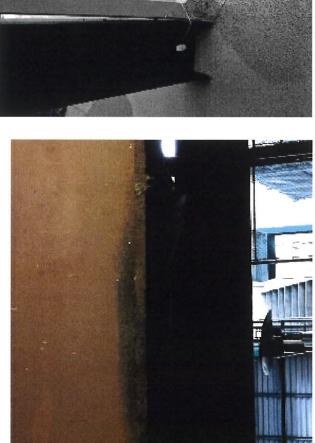
Leaks causing structural rust

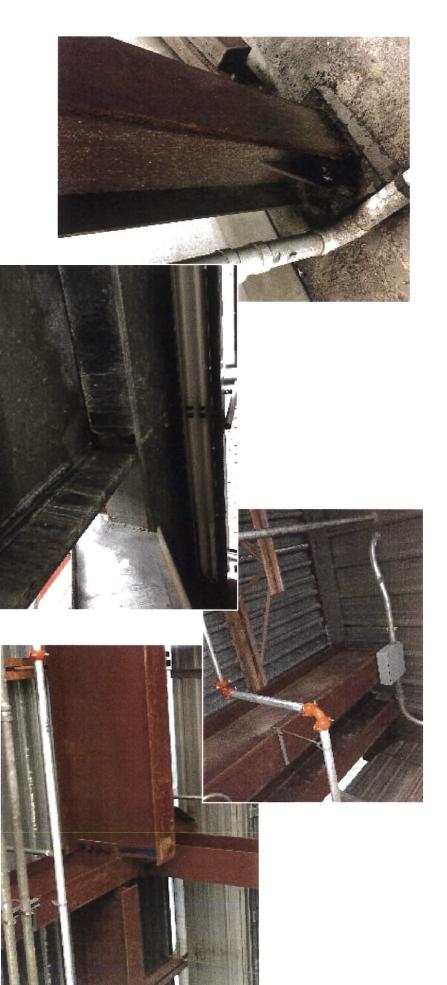
Exposure: Structural steel members are beginning to show signs of rust.

Impact: Unsightly appearance and eventual structural weakening.

Examples of rusted steel structural members

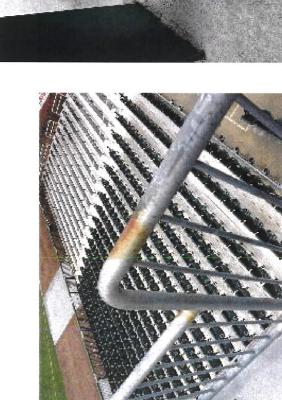
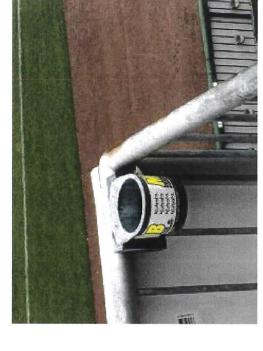
Exposure: Unsightly rusted areas on handrails throughout the stadium.

Impact: Eventual safety handrail failure.

Typical examples of rusted galvanized pipe handrails

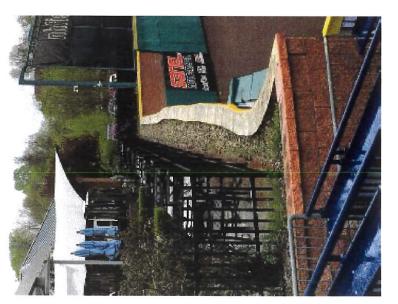
Exposure: Retaining walls are beginning to tilt into the playing fields.

Impact: Walls will eventually collapse, possibly causing severe personal injuries.

North retaining wall should be a straight line.

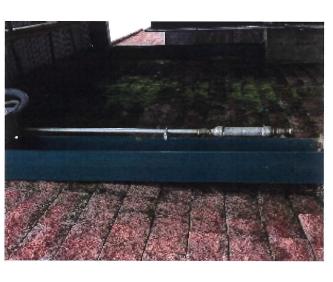
South wall is leaning at the top as seen above.

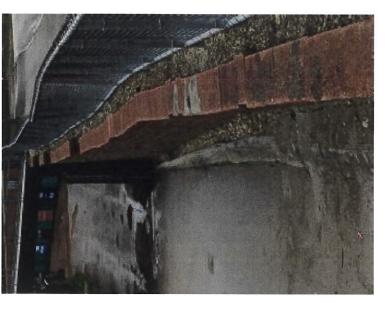
South retaining wall is tilting towards the left.

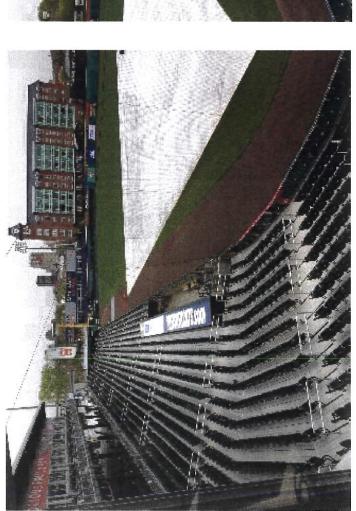
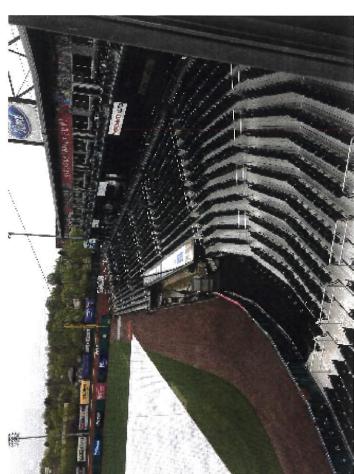
Exposure: Numerous non-functioning seats along with broken anchors.

Impact: Potential for physical injuries as well as limiting seating capacity.

General view of open stadium seating

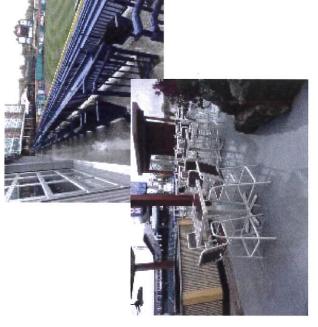
Exterior bar, veranda seating, and reserved seating served by existing lavatory.

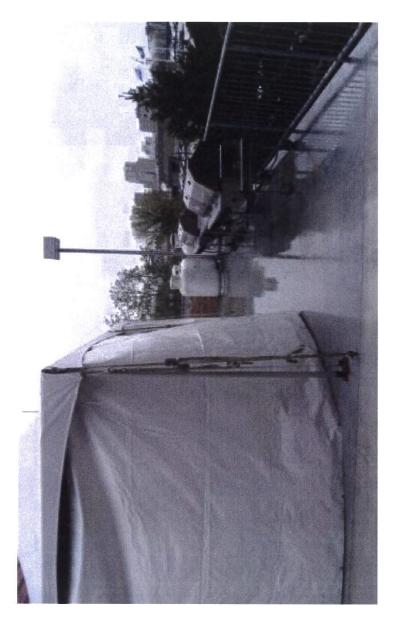
permanent electrical service outlets, normal or emergency lighting, appliance circuits, etc. Exposure: The temporary outdoor kitchen supporting the Sam Adams Bar & Grill has no

Impact: Temporary services can be unsafe and not intended for long-term use, nor are they

Temporary kitchen facilities, housed in tent, with no permanent electric services.
